# Preliminary Analysis of 0206 Earthquake in Southern Taiwan

Kuei-hsiang Cheng\*

Kao Yuan University, 1821, Zhongshan Rd., Luzhu District, Kaohsiung, Taiwan (R.O.C.).

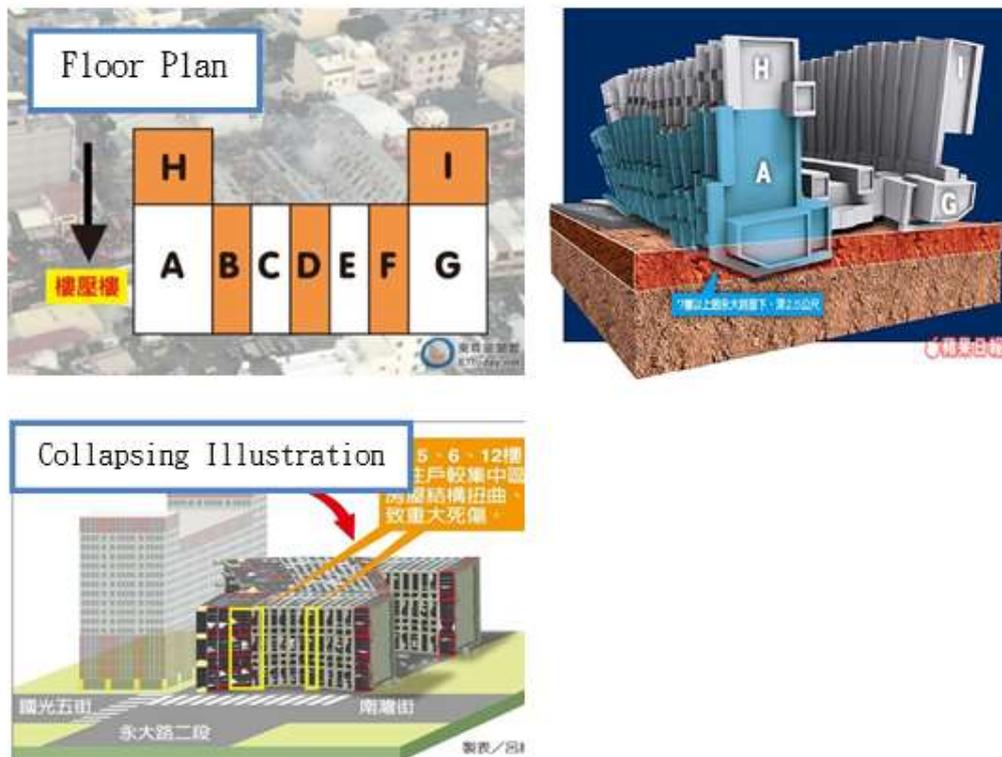
**Figure 5.** Floor plan and collapsing illustration (ETtoday 2016; Appledaily 2016; Udn News, 2016)

This earthquake caused 14 buildings collapsed where among them the 3-apartment building complex was the most serious incident with 115 residents lost their lives. This residential building complex was an RC based building and 22 years old before it collapsed. Its construction was completed in 1994 after its construction admission was given in 1992. Right before its completion in 1994, the design of it was modified (the partition walls of 1F to 4F were cancelled). The floor plan and collapse illustration are shown in Fig. 5.

Yonkang Dist. reached CWB intensity 5 in 0206 earthquake. There was no soil liquefaction but the source and site effects imposed a big impact to this weak building complex. We divide this into two aspects: design failure (NEXT Magazine, 2016) and improper construction process.

(a) Design failure:

1. The building complex was a “ $\Gamma$ ” shape. This shape easily forces too much strain concentrated on the outer corners and caused weak earthquake-resisting capacity on A and G buildings.

2. It is the law that buildings which are over 50m high are required a substantial examination by the government. Weiguang buildings were only 49.9m, which was doubted that the constructor was on purpose to avoid this examination.

3. There were no partition walls from the first to the fourth floors in A、B、C buildings. The insufficient quantity of pillars made these floors weaker than others.

4. In 1994 the design was modified. In buildings B to F, the four load-bearing walls were eliminated so the earthquake-resisting capacity became weak.
5. With 16 stories above the ground and only 1 floor of basement, the lack of foundation in Weiguang was an improper design which resulted in this tragedy.

6. The first floor was next to the road so the arcade was designed for business reason but this led to the unbalance of the buildings and caused them to fall down to this side which had less pillars.

7. It is not correct about the lap joint of girder (crossbeam).

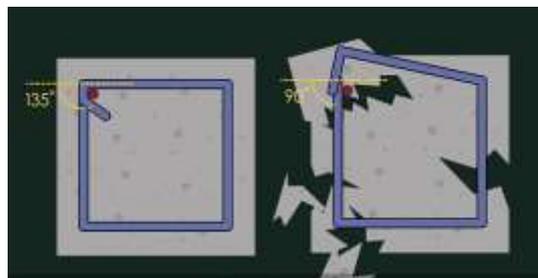
**Figure 6.** Schematic of beam-column joints (Chinatimes, 2016)

1. The stirrup of pillars was only 90 degrees which was less than the new law with 135 degrees after 921 earthquake in 1999 (see Fig. 6). This resulted in weaker structure to earthquakes.

2. The density of stirrup was insufficient among beam-column joints, which did not

match the 5-10-cm regulation.

3. The quantity of stirrup from the first to the fifth floors was near 50% less than it was in the structure calculation sheet. Therefore, the joints had less strength against earthquakes.
4. The construction of rebar in columns was not applied in split-level lap but in block format. This also made the strength weaker.
5. The visible rebar on site was very clean, which may indicate the insufficient bondability.

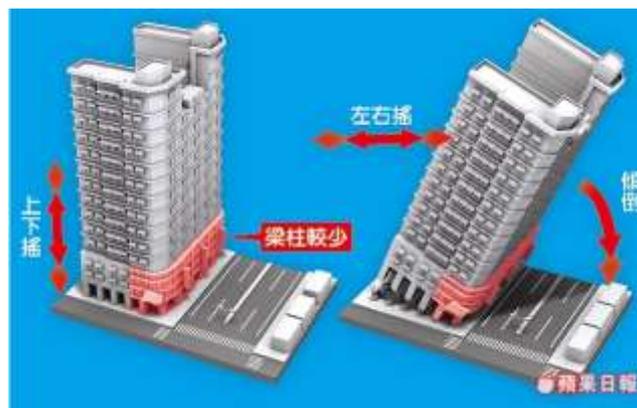
**Figure 7.** Schematic of Weiguang Building Collapse (Appledaily, 2016)

Figure 7 shows the schematic diagram of Weiguang building collapse. The collapse of the building was due to improper design firstly and bad construction process with the site effect of 0206 earthquake. The earthquake had it swing from east to west and then the foundation was squeezed repeatedly which made the complex fall down to the road ahead.
