Assessment of seismic vulnerability in reinforced concrete buildings in Tawau, Sabah: A study on damage potential

Samnursidah Samir¹, Noor Sheena Herayani Harith^{1,2#}

ABSTRACT Tawau located in Sabah is deemed to possess a moderate level of seismic activity, primarily because previous earthquakes were concentrated in the Lahad Datu-Tawau region due to the existence of an active fault. Regrettably, a significant number of reinforced concrete (RC) buildings in this area lack awareness and comprehension of earthquake-resistant construction practices, which necessitate the evaluation of building vulnerability in high-seismic-hazard zones. The goals of this study are to conduct fieldwork for the evaluation of the damage potential on 105 existing RC buildings and develop a building damage map in the Tawau area. This entails employing Rapid Visual Screening (RVS) surveys in accordance with the FEMA P-154 guidelines, employing a scoring system to assess the potential for damage in buildings, and subsequently presenting the results on a map. The results of this survey reveal that most buildings in this study exhibit plan irregularities and vertical irregularities in their beams do not al

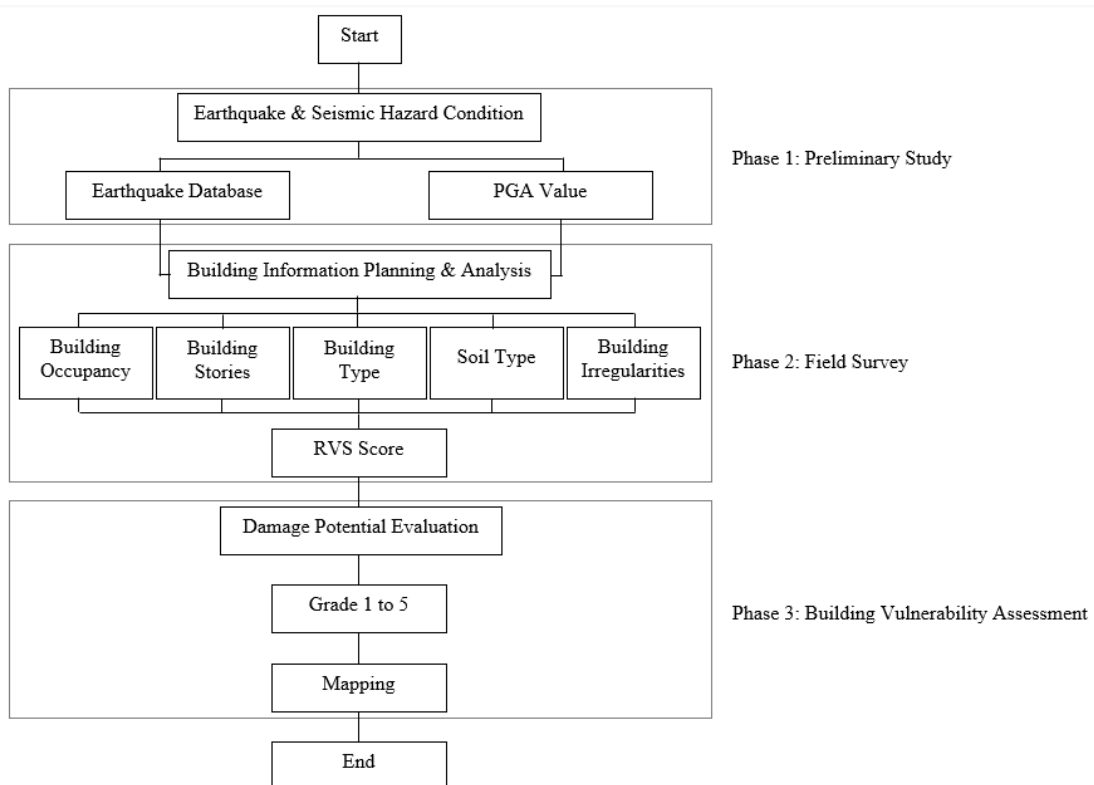
Figure 3. Flowchart of methodology for vulnerability assessment on Tawau RC buildings

The methodology employed in this study, as depicted in Figure 3, encompasses three distinct phases: the preliminary study, field survey, and building vulnerability assessment. During the initial phase, which focuses on earthquake and seismic hazard conditions, a preliminary study was conducted in accordance with the MSEN1998-1:2015 (2017) guidelines. This phase aimed to evaluate the hazard risk associated with earthquakes and seismic activity in Tawau, specifically in the area of Tawau. The preliminary study serves as the foundation for the subsequent phases of the research, providing essential information about the seismic hazard landscape in the region.

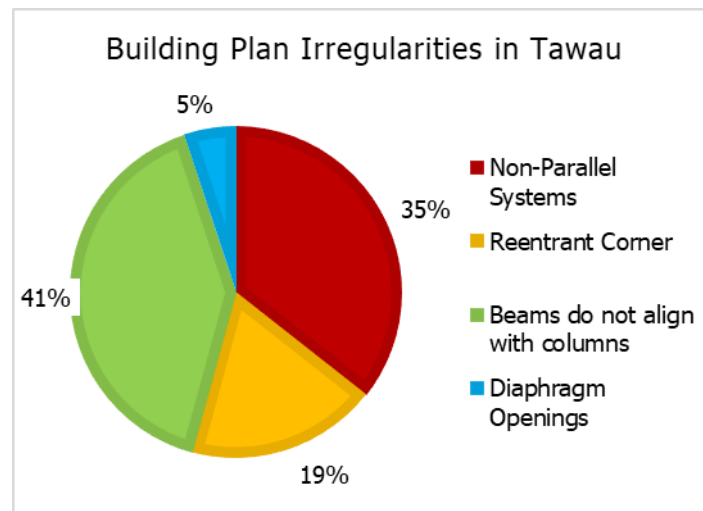
Figure 4. Pie chart of building plan irregularities

Based on Figure 4, the data illustrates that the most prevalent plan irregularity of buildings on beams do not align with columns, accounting for 41% of the cases. The other plan irregularities include non-parallel system (35%), re-entrant corner (19%), and diaphragm openings (5%). In Figure 5, it is revealed that half of the surveyed buildings have vertical irregularities, particularly those related to a weak and/or soft story (80%). These irregularities are more common than other vertical irregularities such as out-of-plane setback (15%) and split levels (5%). These findings highlight the significance of addressing and mitigating vertical irregularities, particularly those related to weak and soft stories, as they appear to be the most prevalent and potentially damaging irregularities in the building stock of study area.

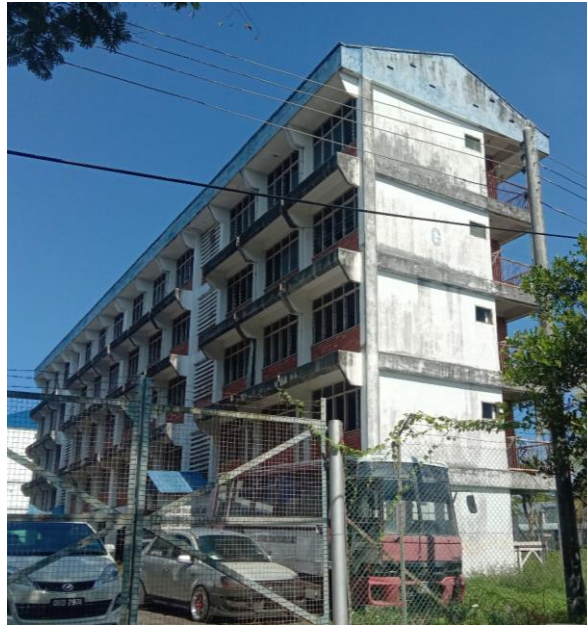
Figure 6. Typical buildings with beams do not align with columns

Most buildings with irregularities where beams do not align with columns, as shown in Figure 6 throughout the survey, can indeed introduce significant vulnerabilities that compromise a building's ability to withstand earthquakes. Proper alignment and connection between beams and columns are crucial for the structural integrity and earthquake resistance of a building. The beams and columns work in unison to transfer the loads or forces acting on a structure. Columns are responsible for bearing vertical loads, while beams carry horizontal loads. When these components, beams, and columns, are not correctly aligned or connected, they may not effectively transfer the lateral forces generated during an earthquake. This misalignment can result in an uneven distribution of forces within the structure, increasing the likelihood of structural failure or damage. As noted by Somma *et al.* (2015), the complexity and magnitude of the forces exerted on a building during an earthquake

have a significant impact on the strength and performance of its individual structural components. In the context of structural engineering and earthquake resistance, the proper alignment of beams and columns is fundamental to ensuring the safety, stability, and resilience of a building during seismic events. Addressing irregularities in the alignment of beams and columns is an important step in enhancing the earthquake resilience of structures.

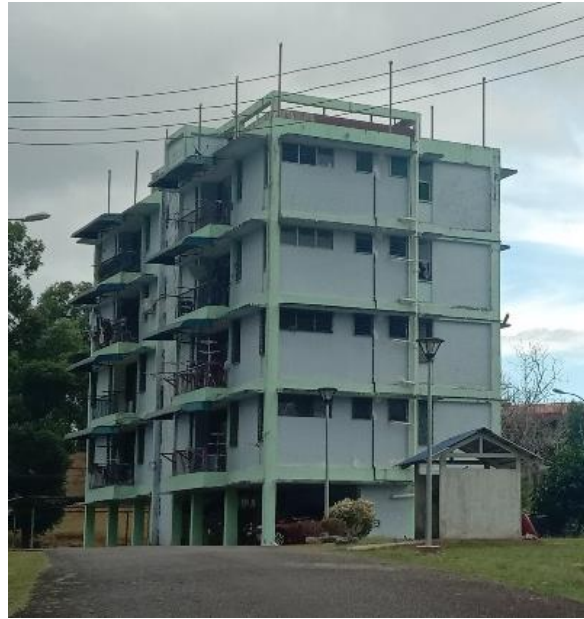
Figure 7. Typical buildings with weak and/or soft story

In addition, the majority of buildings with irregularities on weak and/or soft story identified in Figure 7 during the survey, can significantly increase the seismic vulnerability of multi-story buildings. This vulnerability is particularly pronounced in buildings that have an open area on the ground floor. In the case of soft-story buildings, the design often incorporates a robust beam at the first level but features a weak column design. During an earthquake, the seismic forces experienced by these buildings can lead to significant displacement and damage at these weak column joints, as observed in the research conducted by Dora *et al.* (2017). Previous investigations, as indicated by Ganasan *et al.* (2020), have shown that certain buildings, especially those with soft-story designs, suffered substantial damage during the 2015 Ranau earthquake. This type of failure mode is characterized by the concentration of damage in a single story, typically marked by the absence of infill walls or a bare frame. This results in reduced stiffness in these stories, in contrast to the upper stories that often have infill walls. These findings highlight the need to address soft and/or weak story irregularities to enhance the earthquake resilience of multi-story buildings.
