Comparative Study of Condition Survey Investigation on Building Affected by Bridge Piling Installation

ABSTRACT The building rating system enables the assessor to determine the performance of the building based on approved standards. This paper aims to evaluate the effect of the bridge piling installation on the surrounding building, assess the building condition by using approved standards and propose appropriate rehabilitation to the defects. In this study, the condition assessment of a residential building was performed using three (3) standards; CSP 1 Matrix, BARIS and QCLASSIC 2006. There is a similarity between the concept of the CSP 1 Matrix and BARIS. However, BARIS has a more detailed score evaluation than CSP 1 Matrix. QCLASSIC 2006 covers more specific components that can be evaluated according to Structural, Architectural, Mechanical and Electrical (M&E) and External Works. Based on the CSP 1 Matrix and BARIS analysis, the building is in Fair condition and requires attention for repair works. The data obtained from QCLASSIC analysis is 17.44%. This percentage indicates that most of the elements do not comply with the standards from CIBD, and the performance of the buil

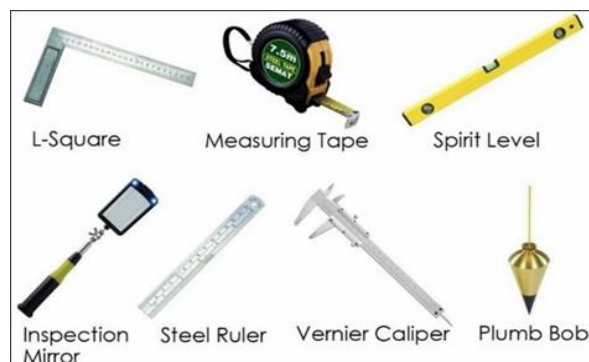
Figure 2. Building Inspection Tools

Figure 2 illustrates the standard tools used for building inspection. The data from the building inspection will be assessed using three (3) mentioned steps and analysed using Statistical Package for the Social Sciences (SPSS).

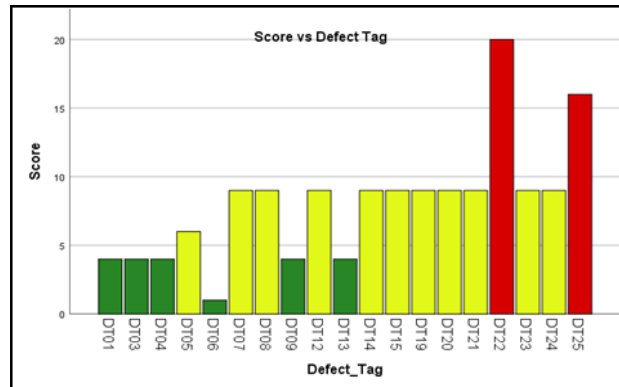
Figure 3. Total Score Defect using CSP 1 Matrix

Figure 3 shows the graph of defects with their computed score using CSP 1 Matrix. Based on the graph, Defect Tag (DF22) and Defect Tag (DF25) are among the defects with the highest scores (red

colour), which are 20/20 and 16/20, respectively. This indicates that the defect is in the damaged category, and the element requires immediate attention to repair or replace the missing part of the structure as it may present risks that could lead to fatality and injury to the occupants of the building (Che-Ani *et al.*, 2008a).

There are defects (yellow colour) which fall under the category of defects which need condition monitoring assessment. The range score of the defects that require such review is around (9 to 12). These defects most likely need significant repairs as they cannot function at an acceptable standard (Che-Ani *et al.*, 2008b). Lastly, there are six defects (green colour) with a range score of about (1 to 4) that only requires minor servicing or monitoring as the defects are most likely cosmetic defects only, and the element can function as expected (Che-Ani *et al.*, 2008b).

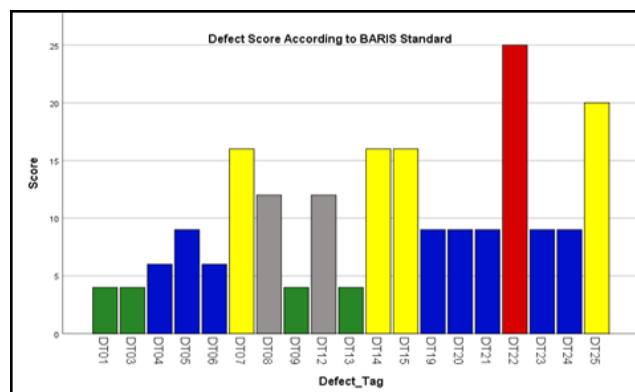
Figure 4. Total Score Defect Using BARIS

By referring to Figure 4, the graph shows the score for the respective defects assessed by the BARIS Standard. According to the graph, the highest score obtained during the visual inspection is on the Defect Tag (DT 22), who scored 25 out of 25 (red colour). This defect falls under a critical category based on the BARIS Standard and requires immediate replacement. In addition, DT 22 acquired a detailed inspection from an expert as this defect potentially affected other structural elements of the building (PWD, 2009).

According to BARIS Standard, the defect tag DT07, DT14, DT15 and DT25 (yellow colour) falls under critical condition. These defects usually do not function under acceptable standards; however, they present risks to the occupants of the building. Two defects with an equal score of 12 (grey colour) were identified during the site inspection. This type of defect is in the average condition whereby major defects encountered by the building can be repaired without replacing any element (PWD, 2009).

Eight defects (blue colour) with a range score between 6 to 9 were found during the assessment. These defects fall under condition-based maintenance, where the building encounters only minor defects. Scheduled monitoring must be conducted for the defects to become more significant (PWD, 2009). Finally, there are four defects which are DT01, DT03, DT09 and DT13 (green colour), categorised under defects that only require monitoring. The defects are usually cosmetic and do not affect the functionality of the building.
